# Oil Refinery Needed a Solution to Stop Costly Leaks from a Heat Exchanger

## CASE STUDY

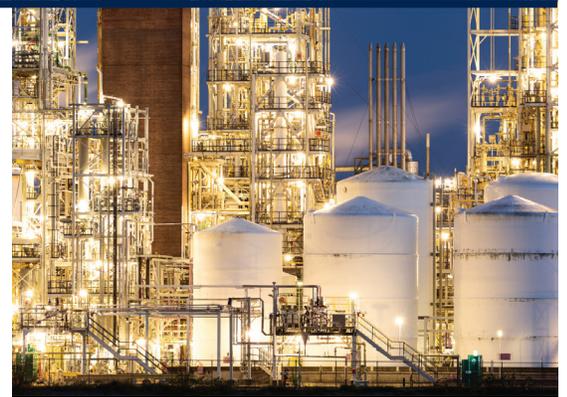
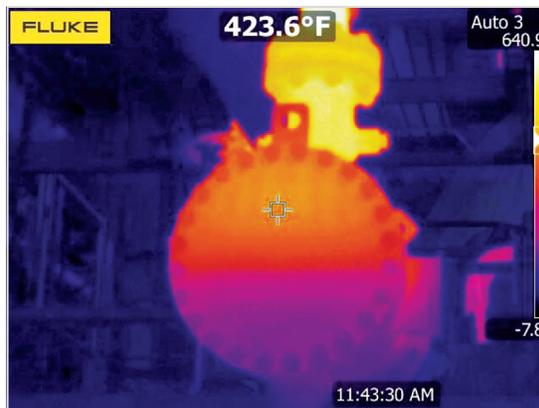
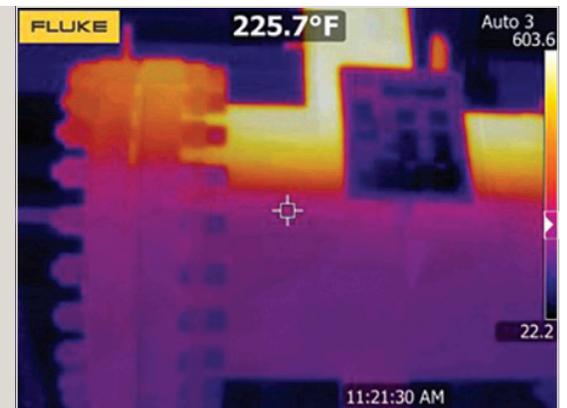
The customer's HF alky unit cycles in pairs (i.e., two cycles at a time) at a regular, once-a-week interval. The heat exchanger on the alky unit was leaking superheated steam and isobutane vapor, which was costly to the oil refinery due to the loss in heat energy and feed product. The steam from the top of the channel moved downward and dispersed at the partition plate, creating a dramatic temperature differential from the top to the bottom of the heat exchanger. This resulted in a loss of bolt load, causing uneven bolt-load relaxation and a loss in gasket stress.

These thermal images capture the temperature difference from the top of the heat exchanger to the bottom

**Lamons CorruKamm CK1**, which provides up to 39 percent gasket recovery, was selected to compensate for the relaxation of bolt load from the temperature cycling. Manufactured at the Houston, Texas facility, this gasket requires precise machining and has a proven track record with heat exchangers and other high-temperature, high-pressure applications in challenging environments.

**Lamons SPC4 load indicating B16 studs** were selected, first and foremost, due to the application temperature exceeding the recommended temperature range for a B7 bolt. Secondly, the SPC4s allowed the customer

to set the studs within five percent, plus or minus, of the ideal bolt load achieved at installation. Lastly, the operator could easily check the bolt load at any time and re-torque them to maintain a uniform clamp load as needed.

**Belleville spring washers** were chosen because they helped trap the bolt load, and they were a great compliment to the SPC4 in maintaining the desired uniform gasket stress.

The CorruKamm CK1 gasket bolted up according to plan, and the SPC4 B16 studs were set at 40 percent of yield strength.
